## **Analysis of the Problem of Natural Gas Waterlogging**

*Maciej Kotuła<sup>1\*</sup>, Aleksander Szkarowski<sup>1,2</sup>, Aleksandr Chernykh<sup>2</sup>*

*<sup>1</sup>Koszalin University of Technology, Poland*

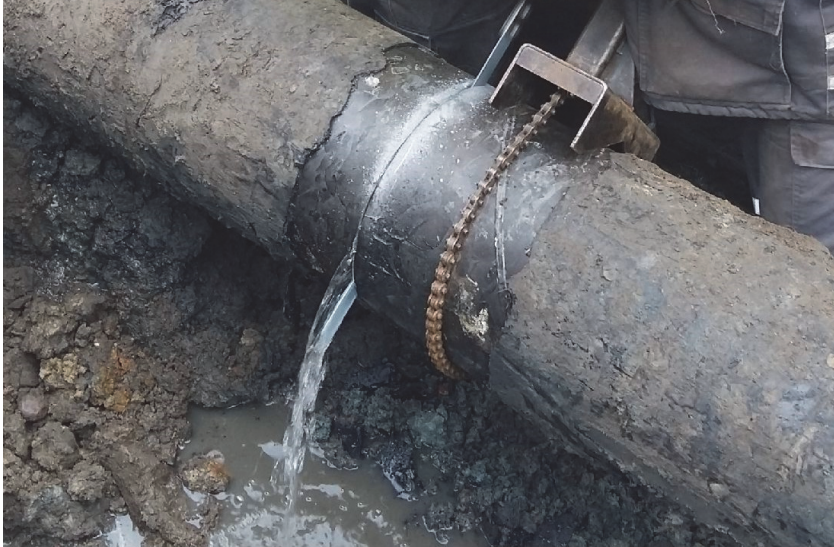
After cutting of the pipe, water escaped from it instead of the gas and a pump was installed instead of the bag-positioning device. In total, about 500 litres of water were pumped out, which meant geometrically that a section of the gas pipeline of the length of almost 7.50 m was completely flooded with water. The sections flooded with water were also found in other areas of the network system (Fig. 1).

The analysis of the causes of the incident from the side of the gas plant was conducted only in one direction - the search for a potential place of leakage which would allow for penetration of such quantity of water into the gas pipeline from the outside. Such a place was not found until these gas pipelines were replaced with new polyethylene ones. Therefore, the thesis that water got into the gas pipeline through the places of leakage has never been proved unambiguously.

**Fig. 1.** Cutting of the DN300 gas pipeline at Myśliwska in Kołobrzeg

This is what happened in the case of the analysed failure in Kołobrzeg. At that time, the use of the dehydrators during construction of passages under the tracks was definitely required due to greater deepening with creation of a natural trap. However, this requirement was omitted during network modernisation.

Appropriate conclusions were drawn only after the failure. Fig. 3 shows the dehydration system prepared for installation during replacement of three sections of the gas pipelines running under the tracks with a new PE gas pipeline with the main diameter DN 355 mm upon the request of the network operator in Kołobrzeg.

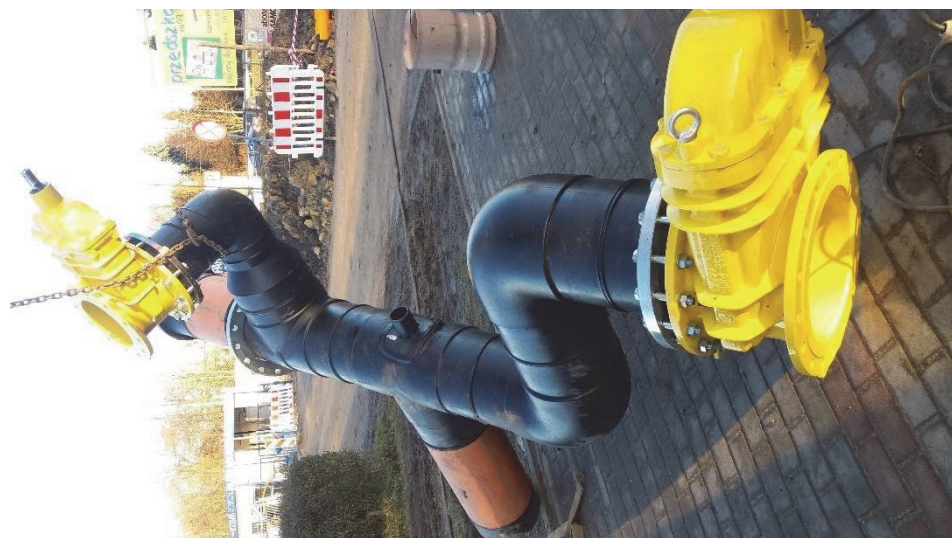
**Fig. 3.** Polyethylene dehydrator with diameter DN 355 (without inspection pipe)
