# RESIDUAL LIFE ESTIMATION OF STRUCTURAL BEAM USING EXPERIMENTAL AND NUMERICAL MODAL ANALYSIS METHODS

**Abstract:** A structural beam is a common element in many mechanical structures such as ship propeller shaft, crane boom, and aircraft wings. In the present paper experimental and numerical modal analysis are carried out for estimating the damage, geometric location of the damage, severity of damage and residual life of structural beam to prevent unexpected failures of mechanical structures. Experimental and numerical modal analysis results for healthy and cracked beam are compared for validation of numerical methodology used in the present paper. Experimental modal analysis is performed on both healthy and cracked beam with the help of impact hammer, acceleration sensor and FFT (Fast Fourier Transformer) analyzer associated with EDM (Engineering Data Management) software. Modal tests are conducted using impact method on selected locations of the entire healthy and cracked beam to find the first three natural frequencies, which are used to detect the presence of damage and geometric location of the damage. Three parametric studies are carried out to know the effect of crack dept

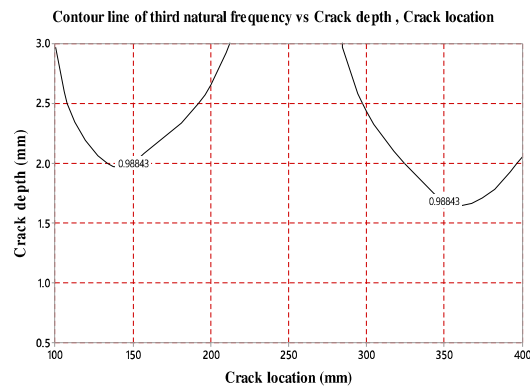
Fig. 18. Contour plot for normalized third natural frequency

depth of 1.25 mm and 2 mm respectively was made at a distance of 150 mm from the fixed end of the beam for estimating the geometric location of the crack. A separate contour plots are made for normalized first, second and third natural frequencies of healthy and cracked beam with the help of Minitab 18 software. A contour plot is a graph between crack depth and crack location for a particular modal frequency. For all contour plots, crack location is taken on the X-axis and crack depth is taken on the Y-axis. Normalized natural frequencies are calculated using Equation-1. Figure 16, Figure 17 and Figure 18 shows the contour plots for normalized first, second and third natural frequencies respectively. As the each natural frequency is unique for a particular crack location and crack depth, the common point of intersection of three contour lines of Figure 16, Figure 17 and Figure 18 indicates the geometric location of the crack. Figure 19 shows the geometric location of the crack present in the cracked beam. This common point of intersection is unique due to fact that each normalized natural frequency of a cracked beam can be represented by a mathematical equation that is depends on crack location and crack depth. Table 9 indicates comparison of actual and estimated geometric location of crack present in the cracked beam using ANSYS 18.1. The error between the actual and estimated geometric location of crack present in the cracked beam is 0.17% to 0.3% only. From the results shown in Table 9, it is confirmed that contour plots of normalized first three natural frequencies of healthy and cracked beam can be used for estimation of crack location in the cracked beam with reasonable degree of accuracy.

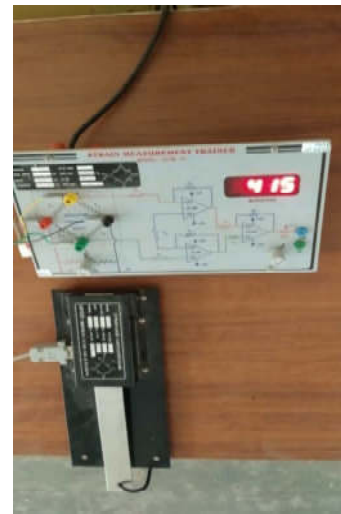
Fig. 20. Image of strain measurement for healthy beam

The residual life of the healthy beam obtained from numerical analysis was validated with the experimental results for validation of numerical methodology used for estimation of residual life of cracked beam. For this purpose, an experimental setup was fabricated for a healthy beam using strain gauges arranged in Wheatstone bridge circuit for measurement of a strain. Figure 20 shows the image of strain measurement for the healthy beam. A point load of 98.06 N is applied on one end of the beam and corresponding strain was taken from digital display connected to Wheatstone bridge circuit. Strain measured from the strain gauge experimental setup is 0.00083845 mm/mm for a load of 98.06 N. The same value of strain is used for calculation stress using Young's modulus of 200 GPa. The corresponding stress is 167.9 MPa for strain of 0.00083845 mm/mm. The value of stress obtained from strain gauge experiment is used for validation of stress obtained from numerical analysis using ANSYS 18.1 for healthy beam. Figure 21 shows the strain generated in the healthy beam. The estimated strain for healthy beam from numerical analysis is 0.00083109 mm/mm and corresponding stress is 166.22 MPa. Table 11 shows the comparison of experimental and numerical stress results of healthy beam obtained from strain gauge experiment and numerical analysis using ANSYS 18.1. From the results it was observed that, the error between experimental and numerical stress results is only 1%. So there is good conformity observed between the experimental and numerical results. Basquin equation gives the relationship between applied stress cycles ( $\sigma_s$ ) and number of life
